## HOW WE CRACKED IT

Ventilating ceiling voids in line with the roof of an existing structure without remedial works to the roof

Combined roof and cladding ventilation. Airflow behind gable-end rainscreen cladding was allowed to circulate into the roof void

Pye Barn, Moulsoford, Oxfordshire

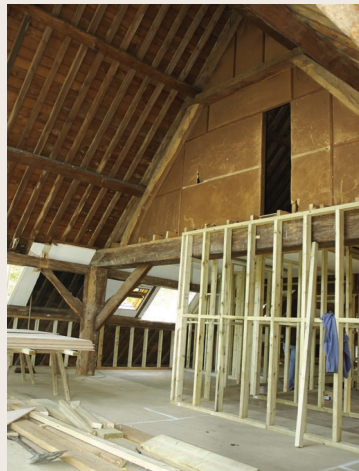
## 1 An existing roof

Having brought the existing roof up to modern standards of thermal performance, we then had to provide ventilation within the roof void so as to dry out any condensation that might occur.

The problem was made more difficult because we wanted the ceiling line to follow the profile of the roof. The existing roof was laid on timber battens fixed to softwood sarking boards. On inspection, it was clear that we could not provide sufficient ventilation without removing and relaying the entire roof. However, budgetary constraints meant this was not a viable option.
